# **Final Report**

## **Shearography NDE of NASA COPV**

**Tests Performed at NASA  
White Sands Test Facility, NM  
Sept. 12-16, 2006**

**Prepared By  
John W. Newman  
October 25, 2006**

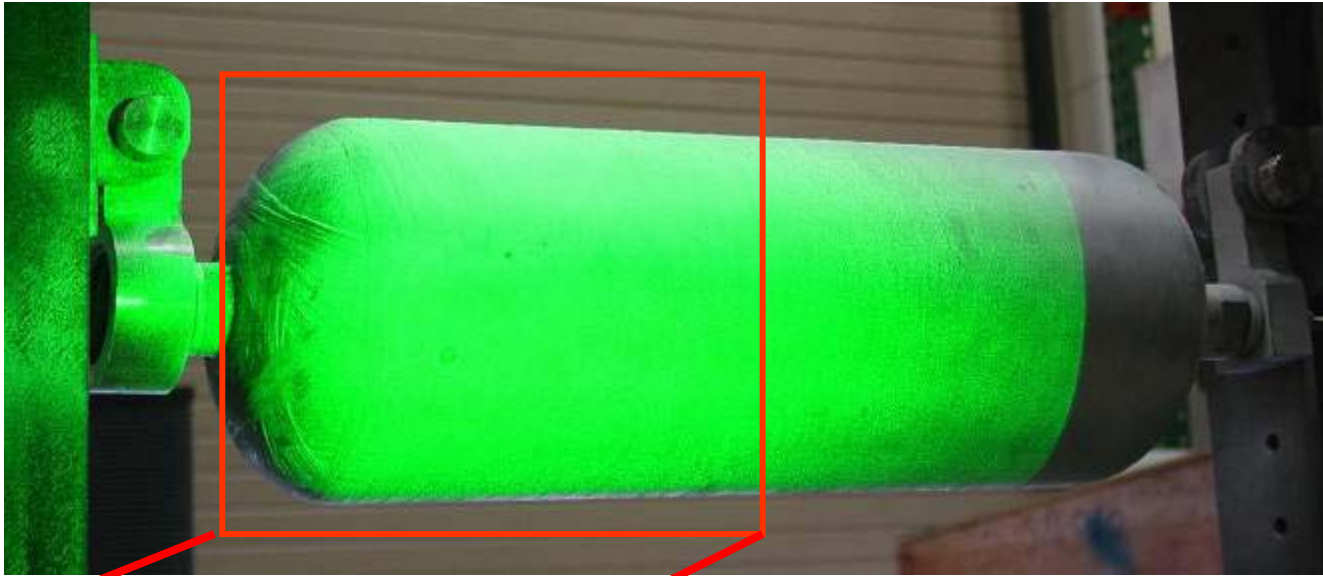
**6 x 22 Inch Graphite COPV Shearography Inspected with 10 psid. Crater like indications are impact induced damage and delamination to the composite.**

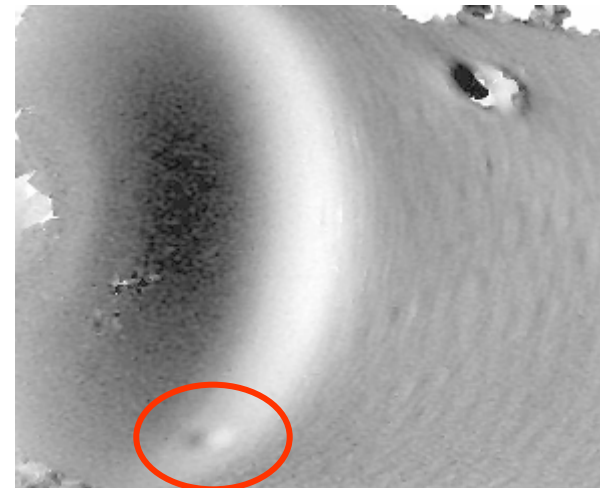
**Un-programmed Damage  
Page 19**

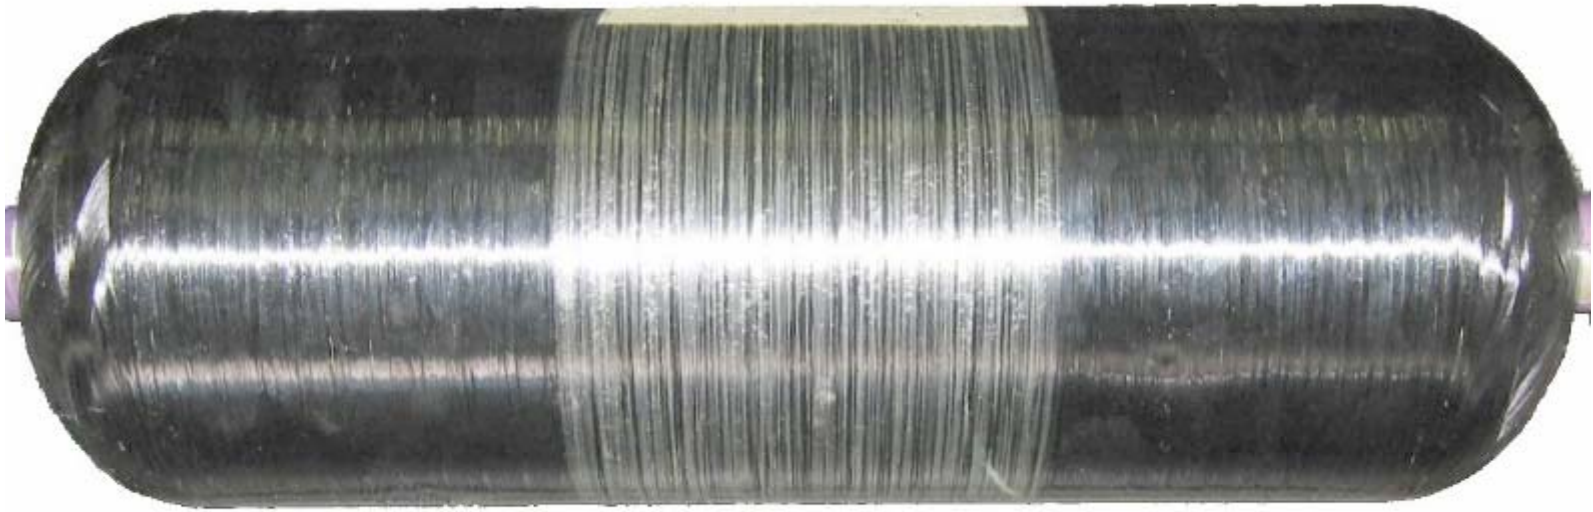
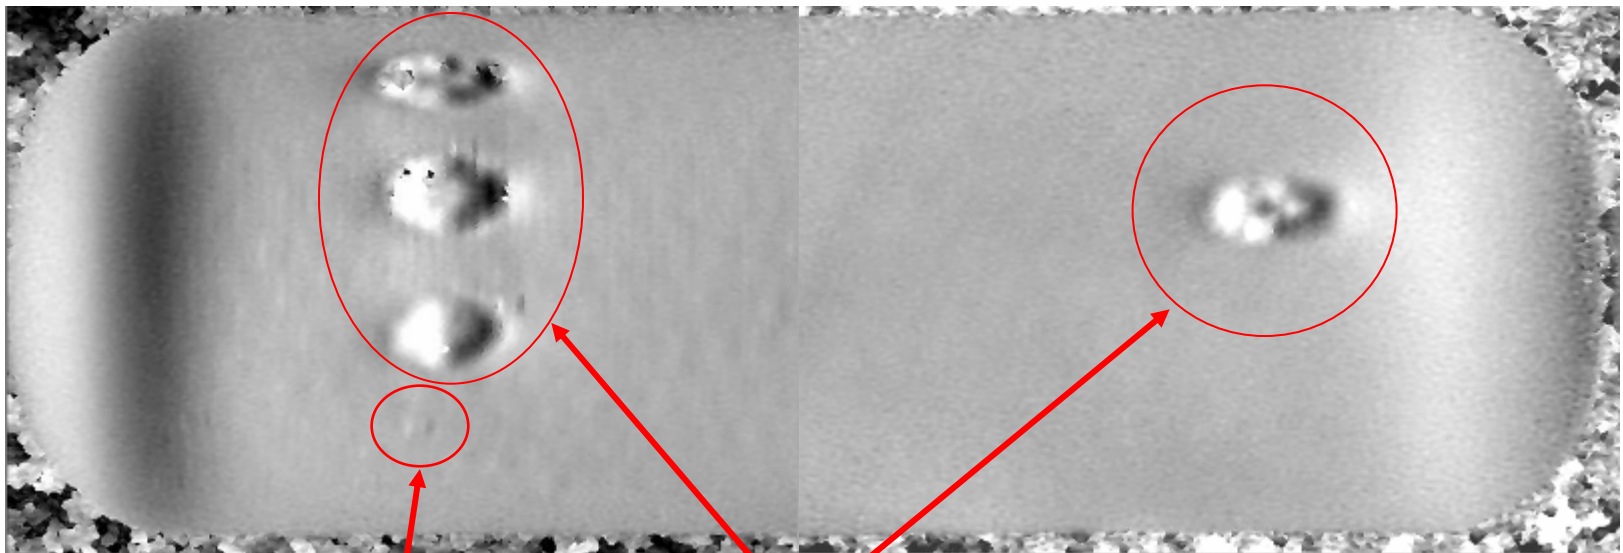
**6 x 22 Inch Graphite COPV Shearography Inspected with 10 psid.  
Three impact areas are seen and one small un-programmed defect.**

**Un-programmed Damage**

**4 Impact Sites**

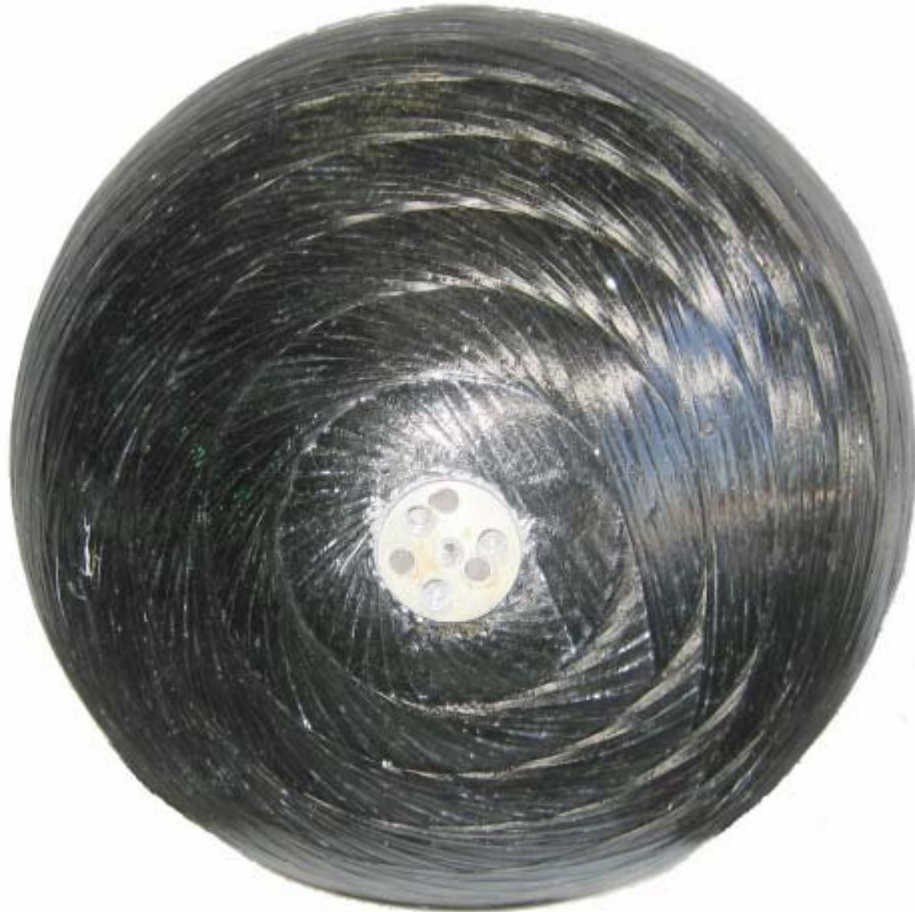
No visible damage except 0.15 inch diameter dimple at impact sites.

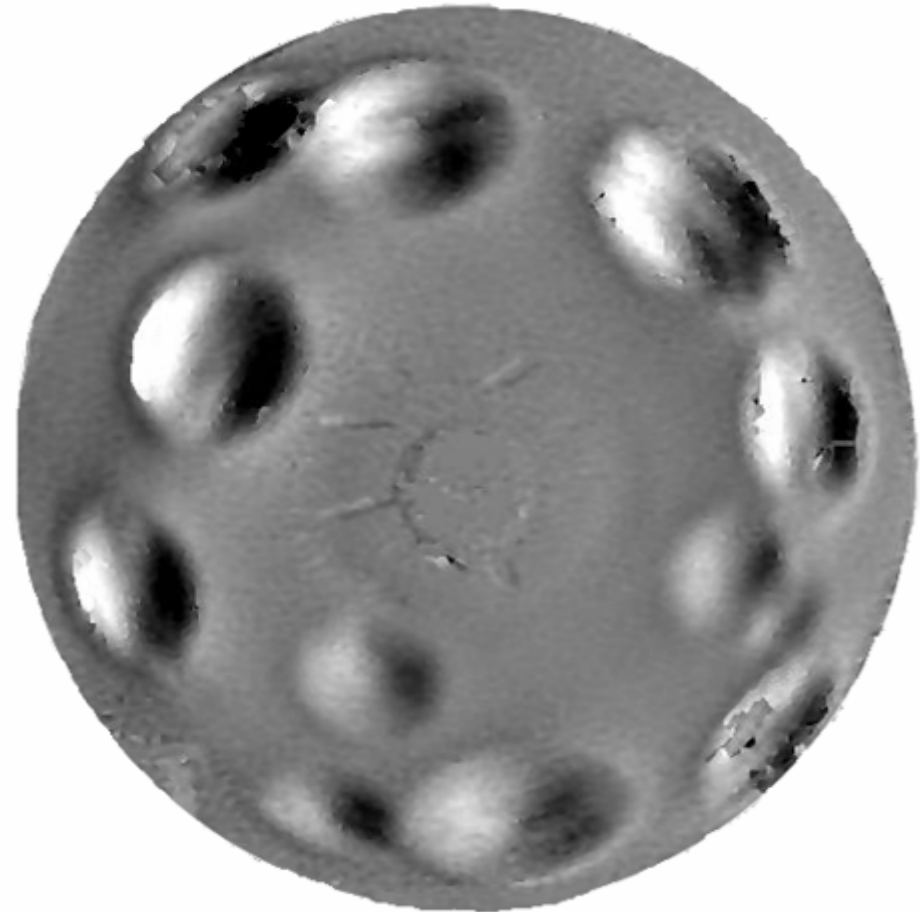
Impact induced delamination .75 to 2.3 inches in diameter.

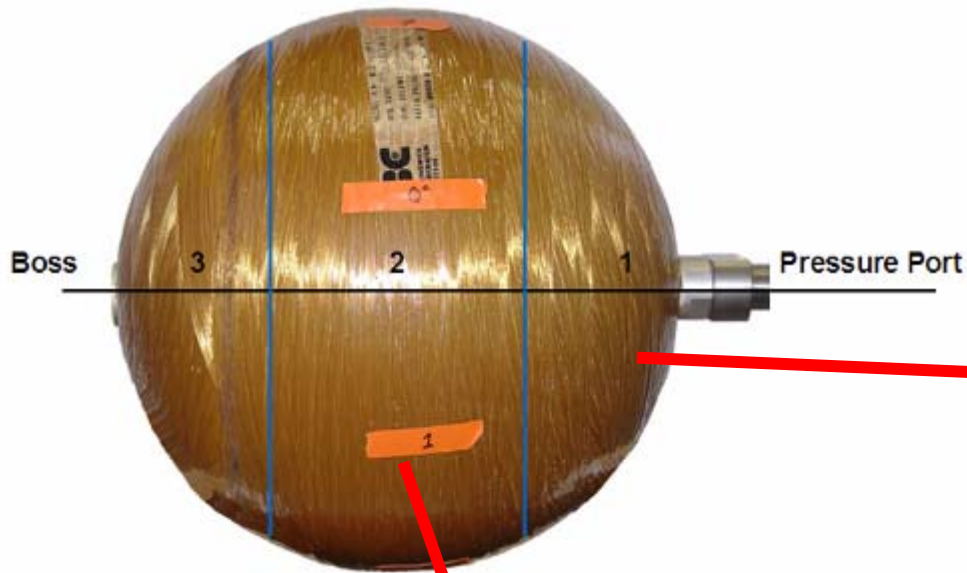
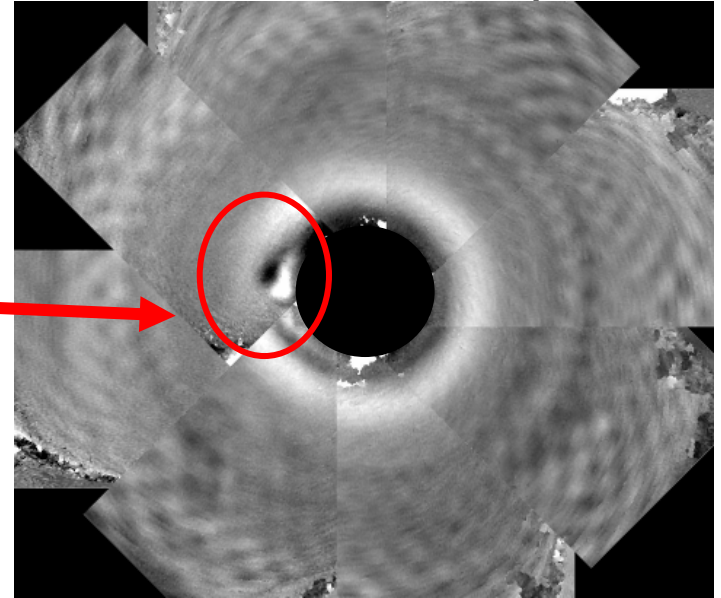
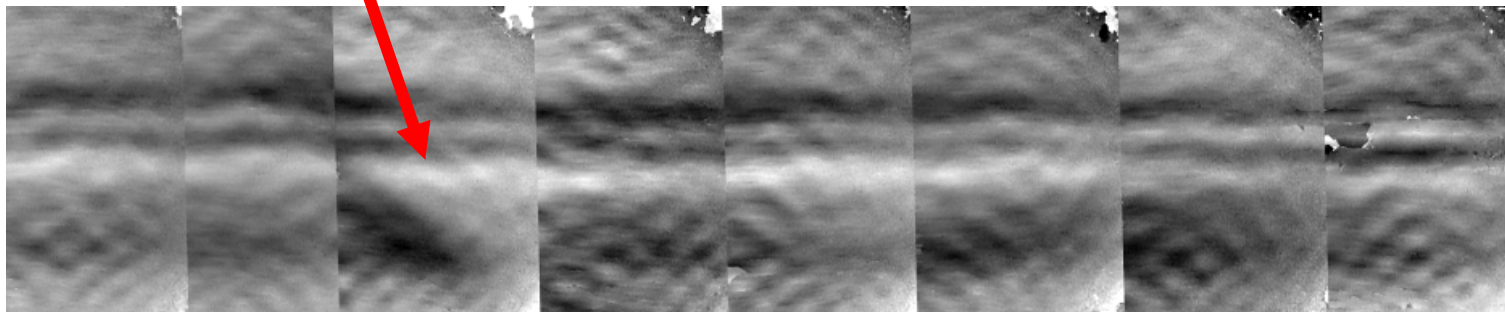
## 10 ¼ Inch Kevlar COPV – Typical Images

Shearography scan Band 1. The pressure port boss is in the center, a stress riser (circled) due to a defect or fiber closure pattern.

Shearography Scan of Band 2 at the equator showing the Strain concentration over the circumferential liner girth weld.

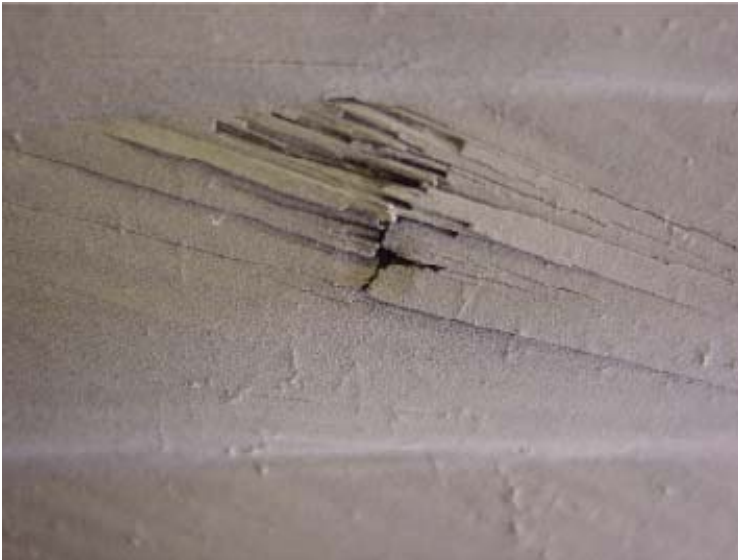
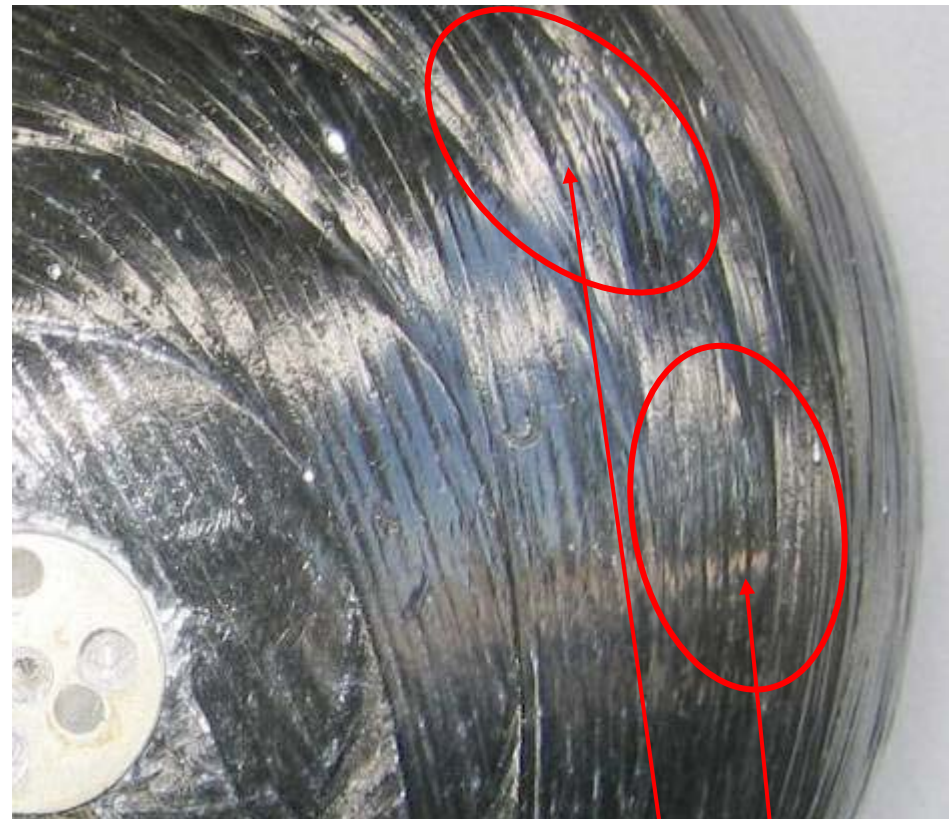
**Visual impact damage for the graphite COPV ranged from severe fracture seen below, enhanced with dye penetrant coating, to little or no discernable damage beyond the very small, 0.1-0.2 inch impact sites seen on 10 ¼ inch COPV at right.**

**Shearography image of area on the 10 ¼ inch COPV above.**

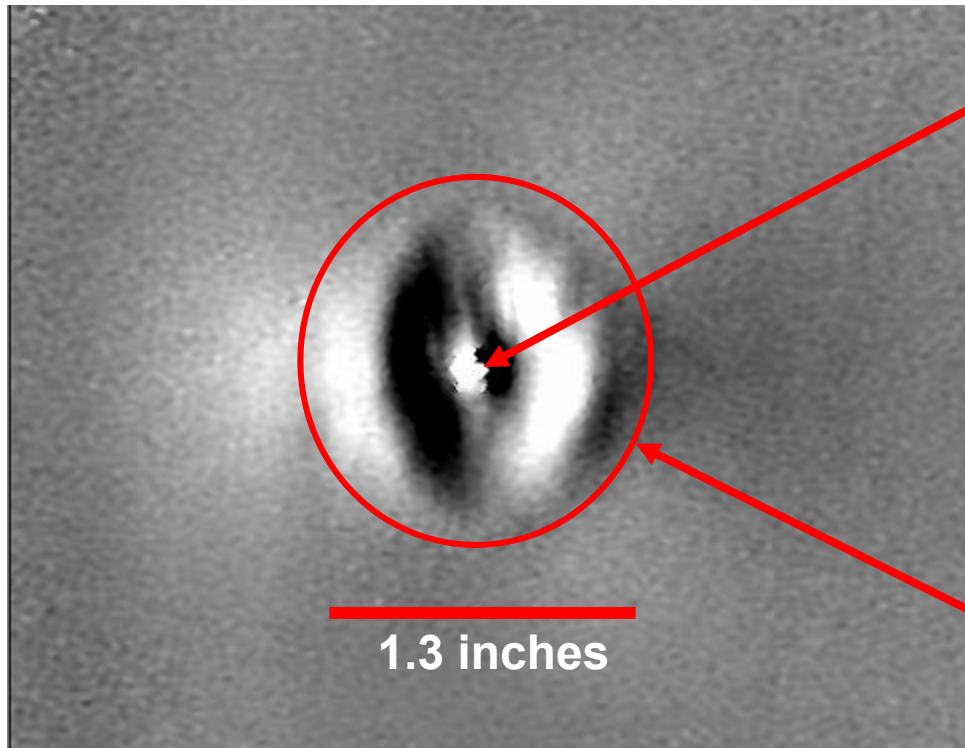
**Impact Site for intentional Defects are seen visually as dimple, fiber breakage and/or color change.**

**Visual indication of composite damage ranged from severe fracturing at area around impact site to a small crack or dimple, to no visual indication.**

**Shearography indications seen in graphite COPV ranged from 0.2 to 4 inches in diameter.**

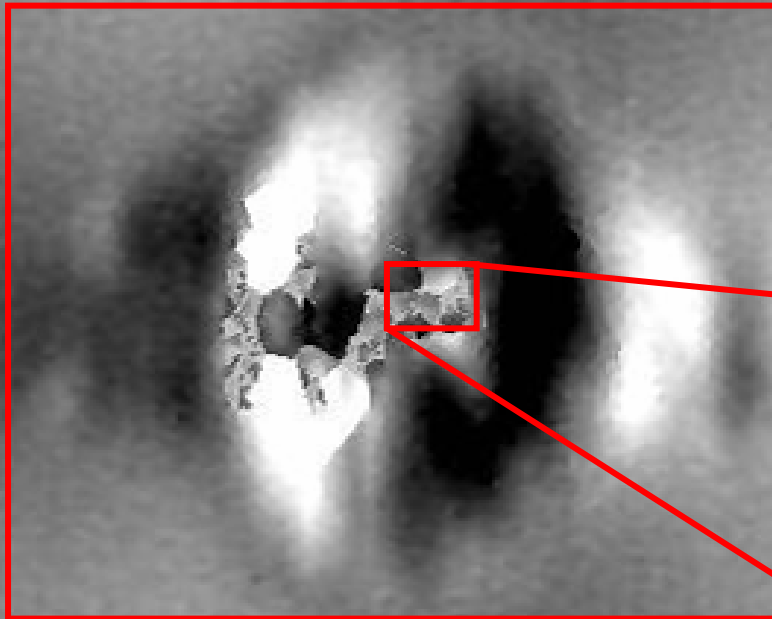
**Shearography Damage Indication  
Measures 4.1 inches**

**Comparison Between The  
Measured Shearography  
Damage Dimensions and  
Visual Damage of 50 Ft-Lb  
Impact @ 180°, 10 Inches  
from Forward Boss**

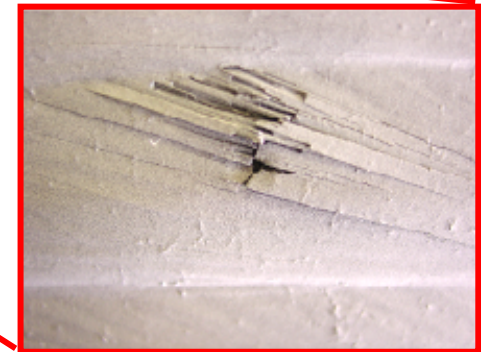
**Visual Damage  
Measured 0.5 in.**

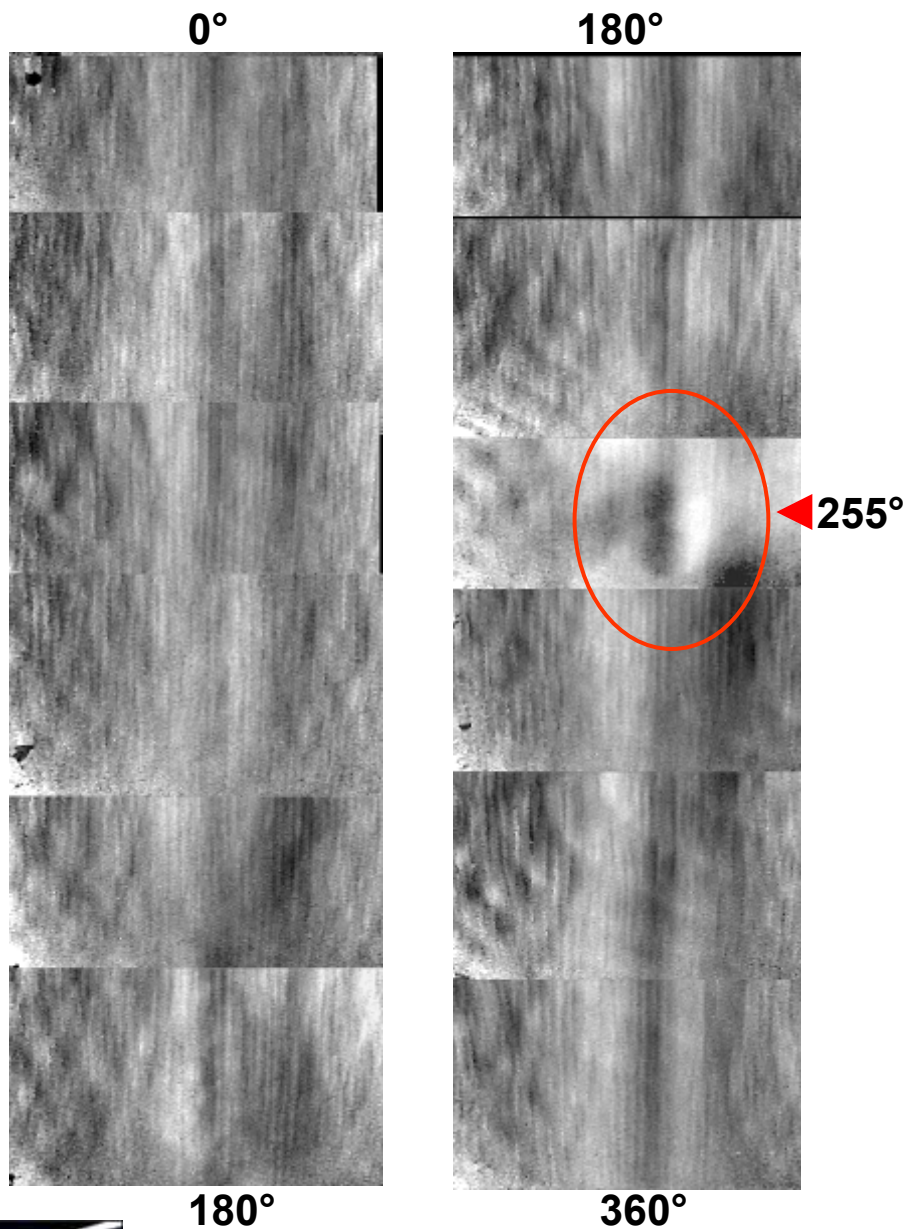
26 Inch Kevlar COPV Fleet Leader s/n 001

s/n 001  
Strain concentration @255°

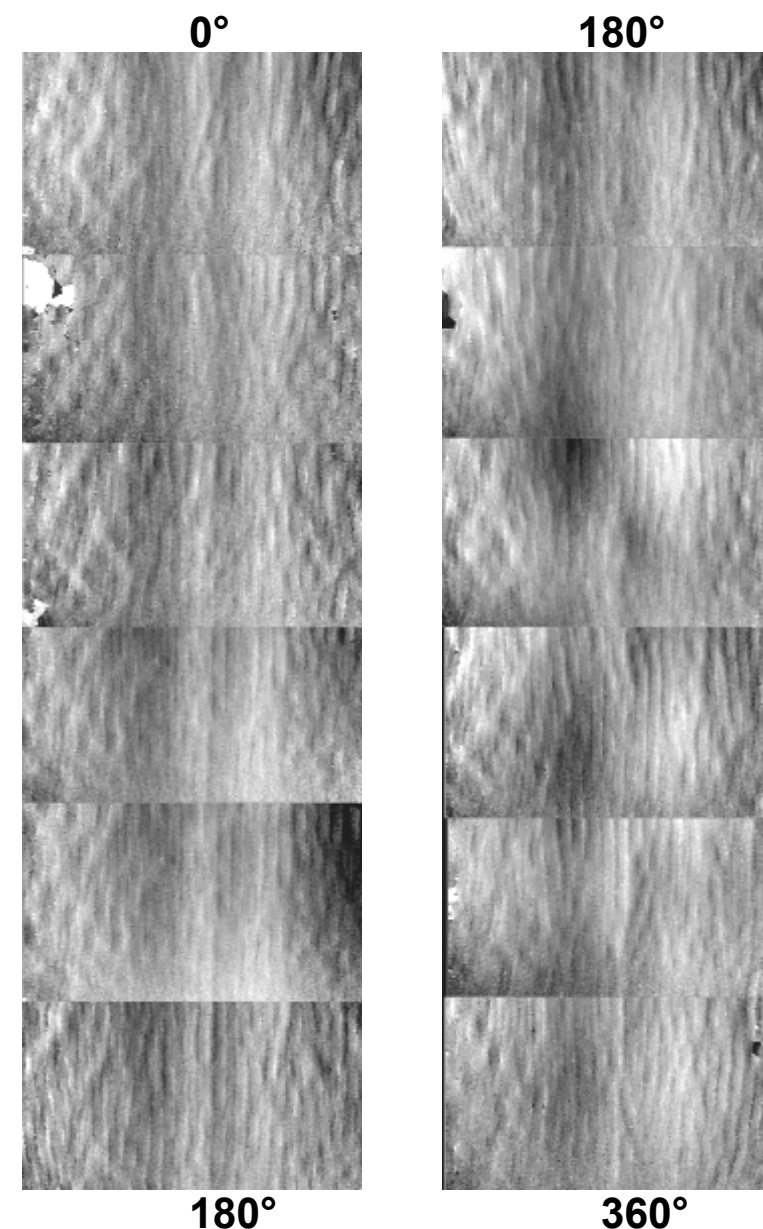
26 Inch Kevlar COPV Fleet Leader s/n 005

s/n 005  
Fiber Delaminations Detected  
Band 4 @ approx. 240°

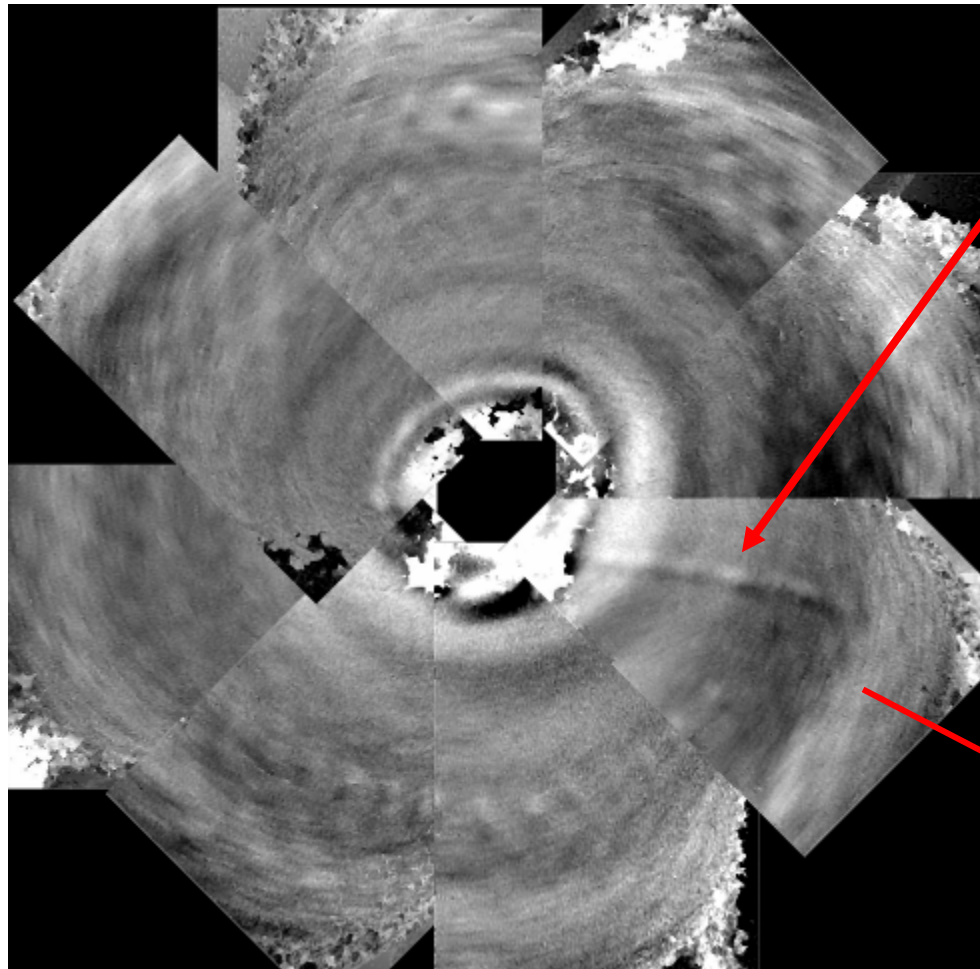
Normal Stress  
Concentration  
Due to Closure  
Pattern at Boss

**Results:  
No Anomaly  
Indications  
Detected**

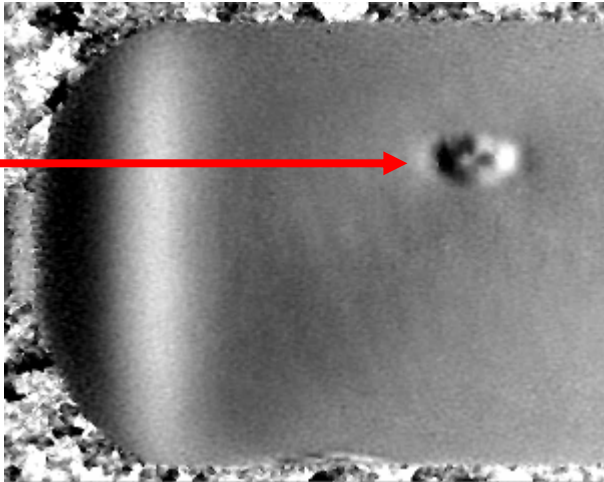
250° x 14.1°  
Damage  
.9x1.5 in.

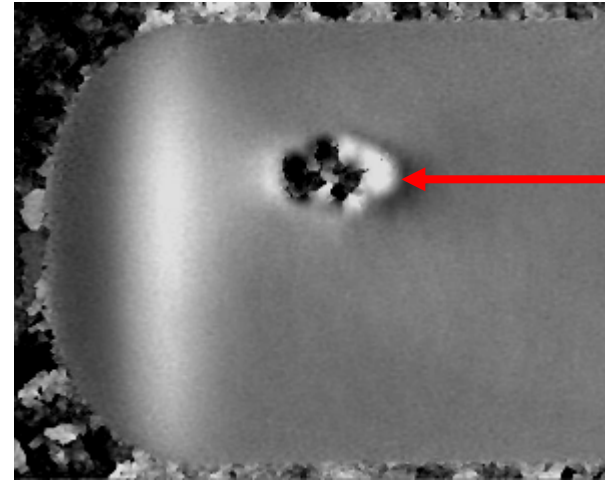
145° x 16.0°  
Damage  
1.3 x 2.2 inch

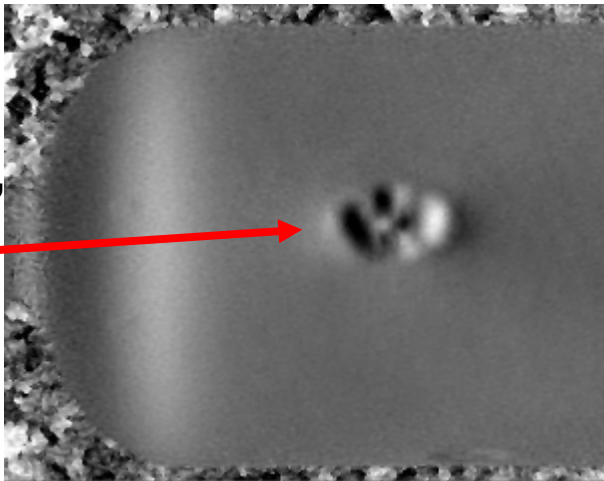
320° x 15.25°  
Damage  
1.1 x 2.0 inch

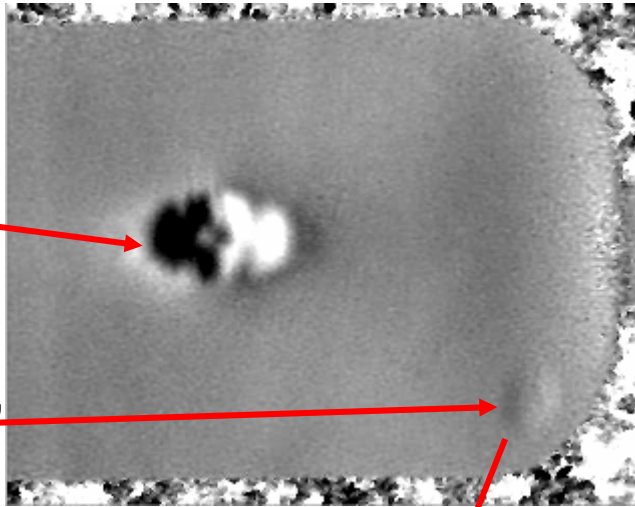
270° x 7"  
Damage  
1.3 x 2.2

290° x 2.8"

Note: Indications at 160°, and 290° are not listed on the VT Score Card provided.

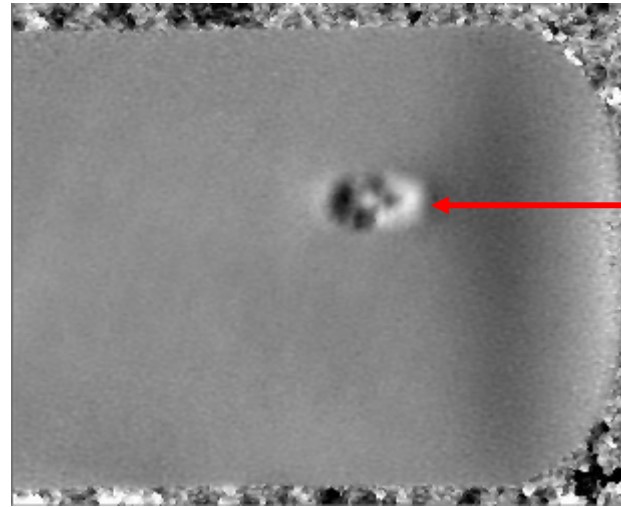
20° x 5.1 inch  
Damage .8x1.5

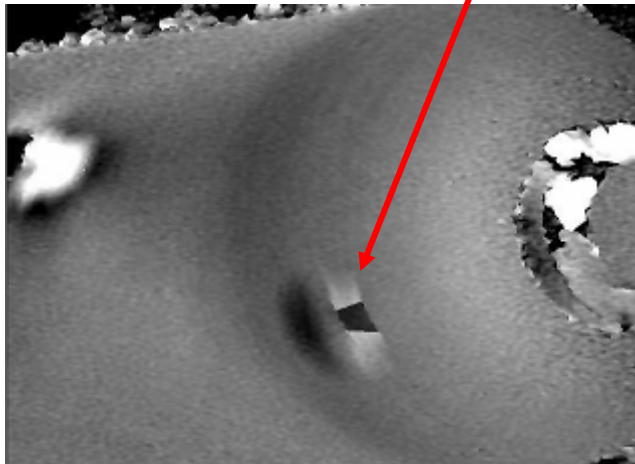
160° x 2.8 inch  
Damage .5x.5

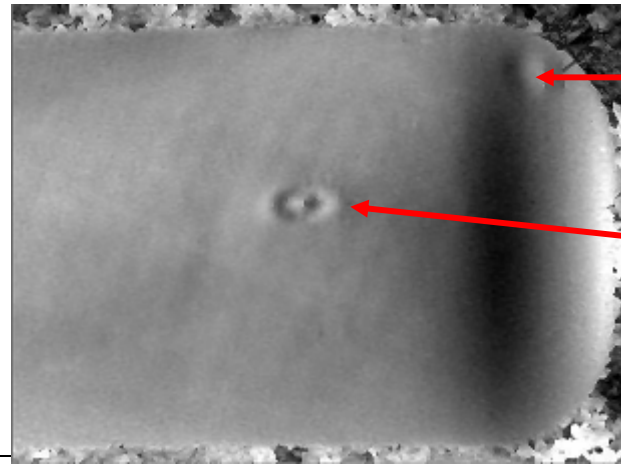
180° x 6.0 inch  
Damage .5 x.9

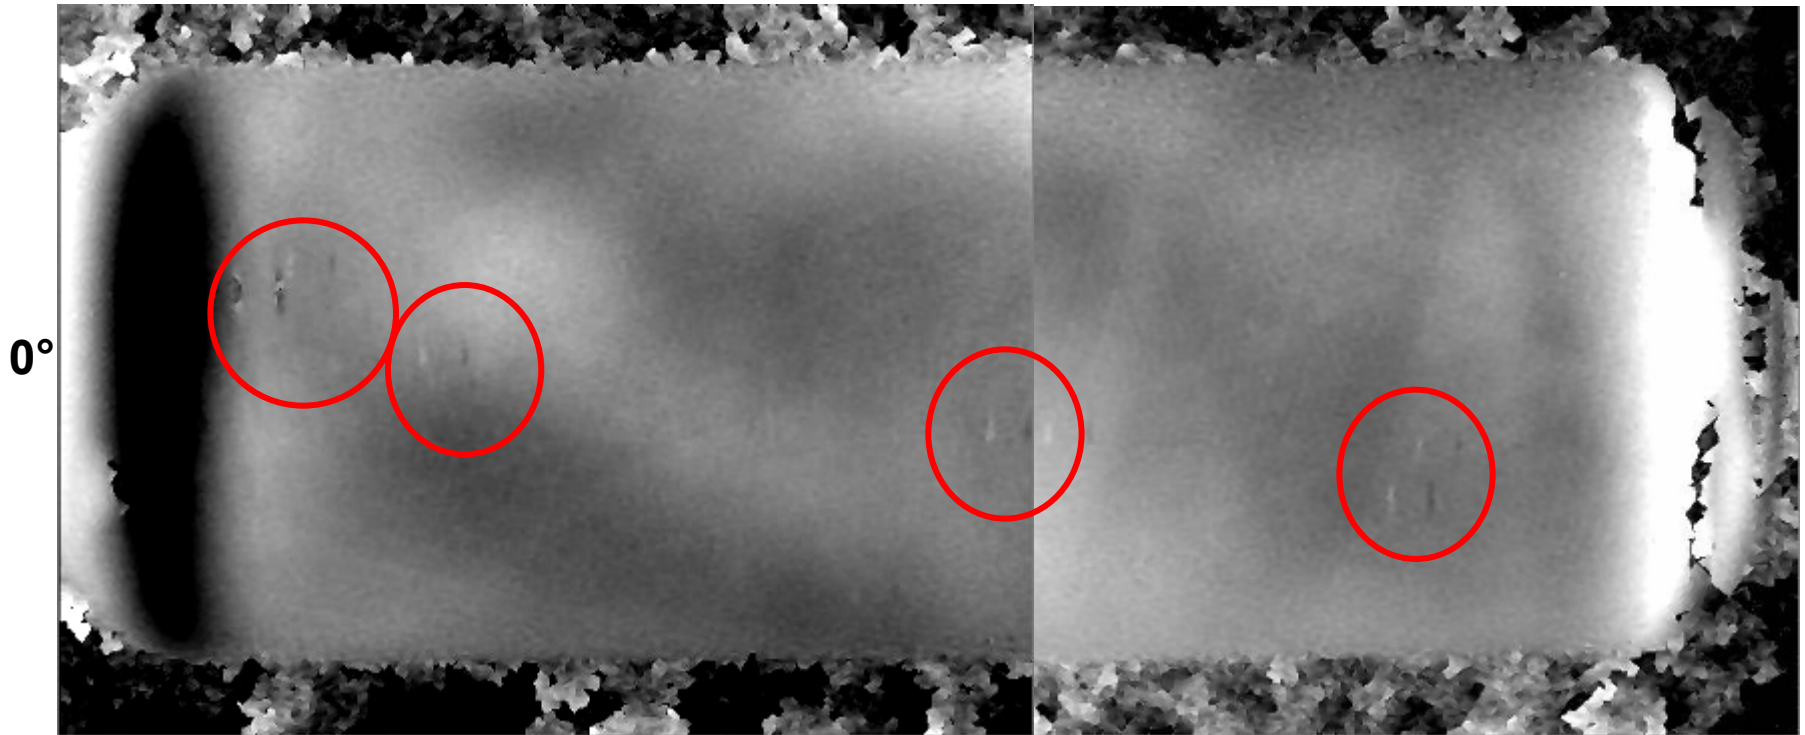
Circled areas are small cracks due to impact.

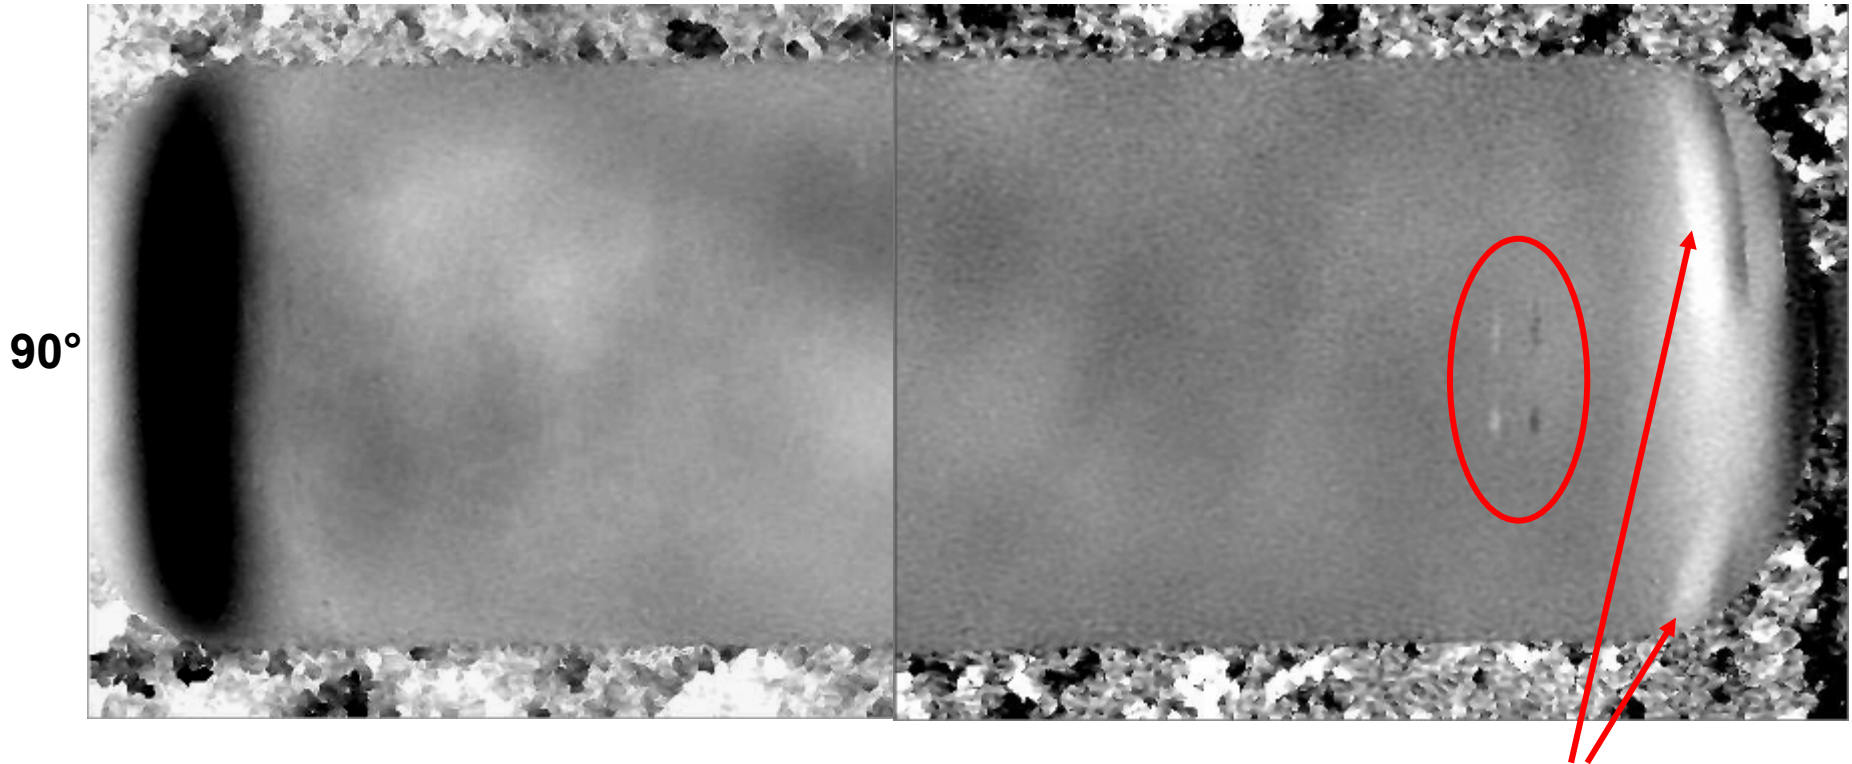
**Bridging Delaminations  
at base of dome end.**

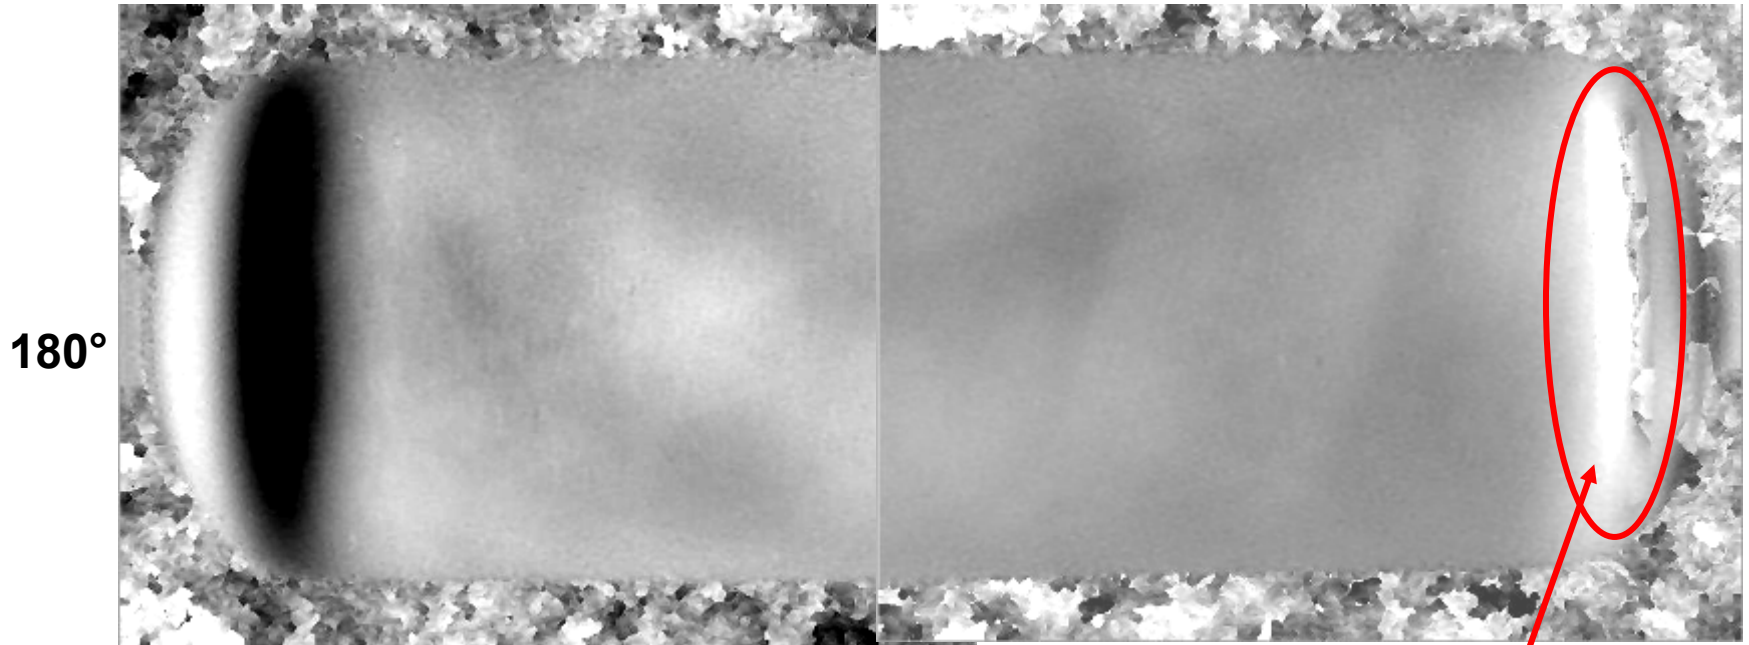
**Bridging Delamination  
at base of dome end.**

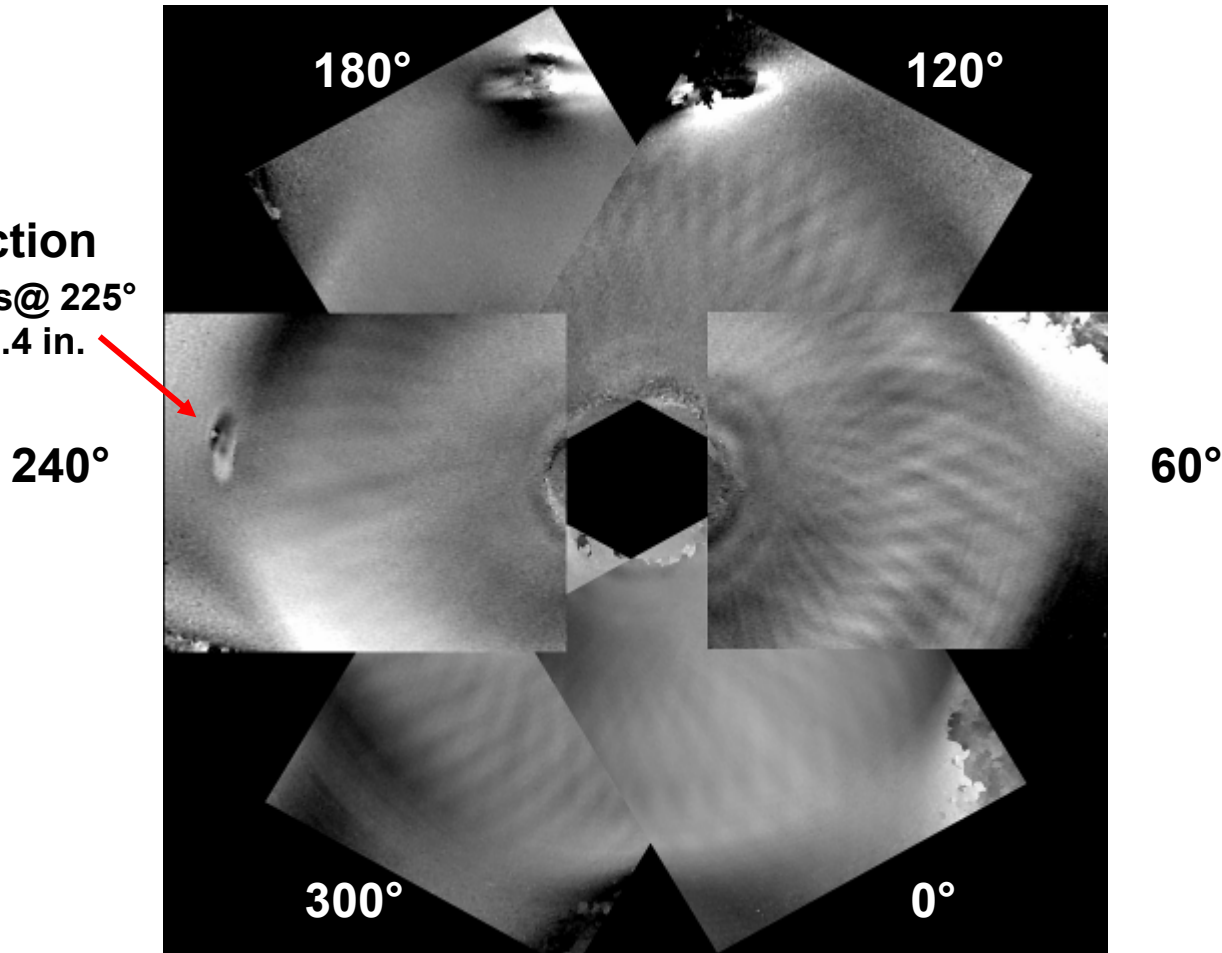
**Impact on  
Barrel Section**  
22.1" from boss@ 225°  
Damage 1.5 x 1.4 in.
